**Site at Junction of Station Road & Blyth Road,  
Southwold  
IP18 6AX**

**Structural Appraisal of Units 1-13**

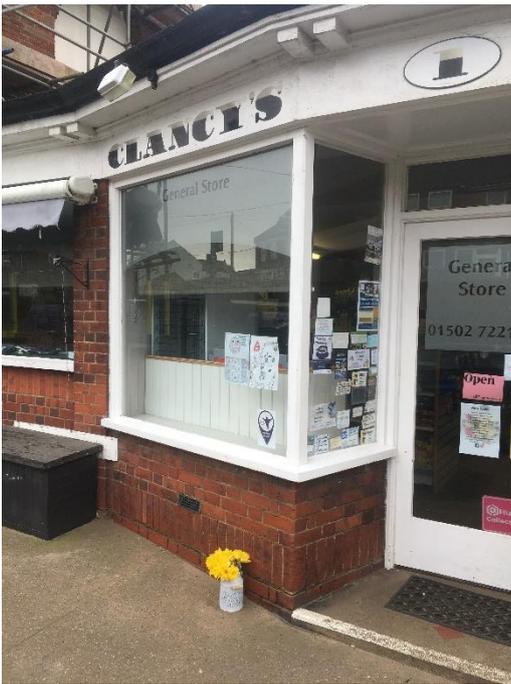
Photograph No. 1 – Front Elevation to Unit 1

5.1.2 The structure has exposed front and side elevations which comprise of red facing brickwork with considerable glazing to the front elevation. The masonry appears to be of solid 215 mm construction and has externally projecting piers.

5.1.3 There was no evidence of any significant structural movement or distortion to any of the external elevations.

5.1.4 A defective rain water pipe was noted to the corner of the front elevation which requires attention and repair.

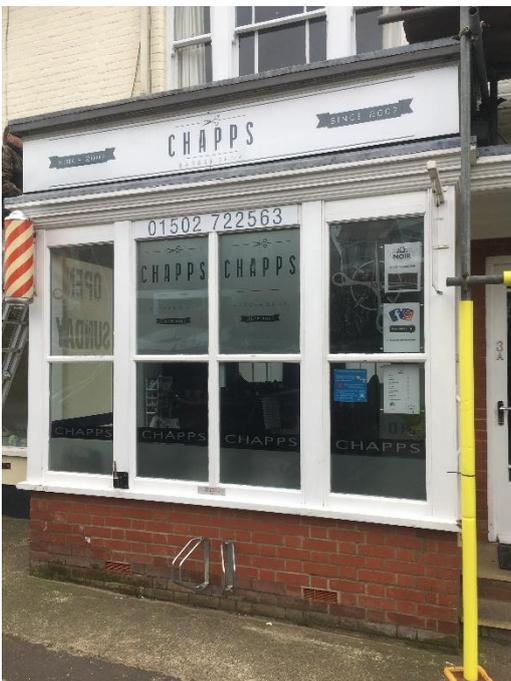
Photograph No. 3 – Modern Front Bay Structure

5.2.3 Both units have identical single storey square bay projections to the front, of modern cavity construction incorporating air bricks to service a sub floor void. The infill masonry to the periphery of the doors also appears to be of the same construction.

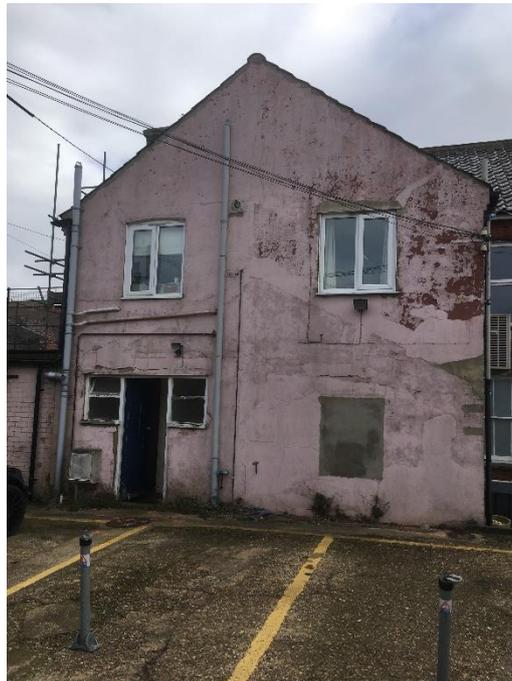
Photograph No. 5 – Rear elevation of Units 3 and 3A

- 5.2.6 The rear, west facing external gable walls are rendered and painted. The render is in poor condition and numerous cracks and spalling above windows can be observed. The window frames are also in a poor condition and require repair or replacement. The patterning on the render face suggest that there may have been a previous single storey pitched roof extension which has subsequently been removed.

- 5.2.9 Generally however, although the render is in a poor condition there is no evidence of any significant structural movement to Units 3 and 3A.
- 5.2.10 There is a later flat roof extension constructed to the North side of the rear projection to Unit 3. This is finished in painted brickwork and appears in a good condition with no evidence of any issues.

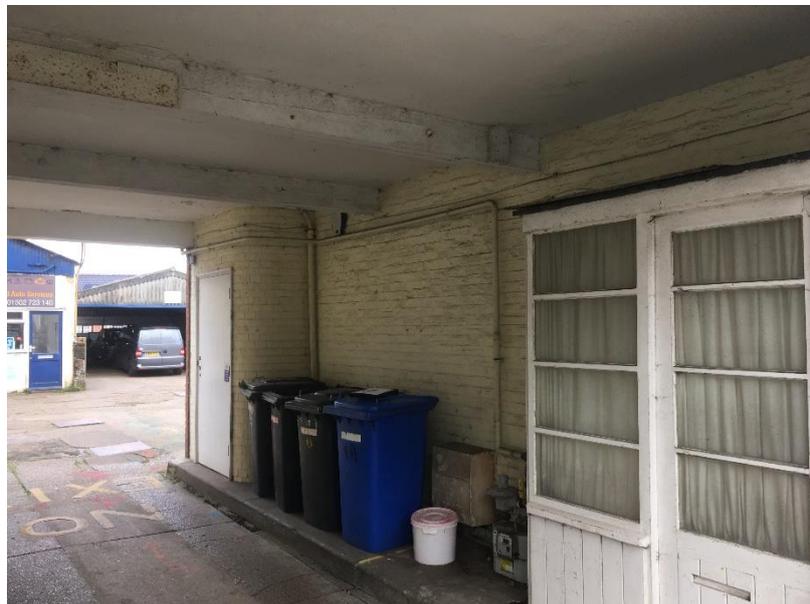
Photograph No. 6 – Flank wall of Unit 5 within access way

- 5.3.4 A chimney stack projects at the ridge location to the party wall with Chapps.
- 5.3.5 To the South of the shop is a covered access way leading to the rear courtyard, with the first floor above. The structure above is supported by a number of timber beams which have been augmented in places with steel flitch plates, with the beams spanning the width of the access way onto the flank walls of Units 5 and 7.

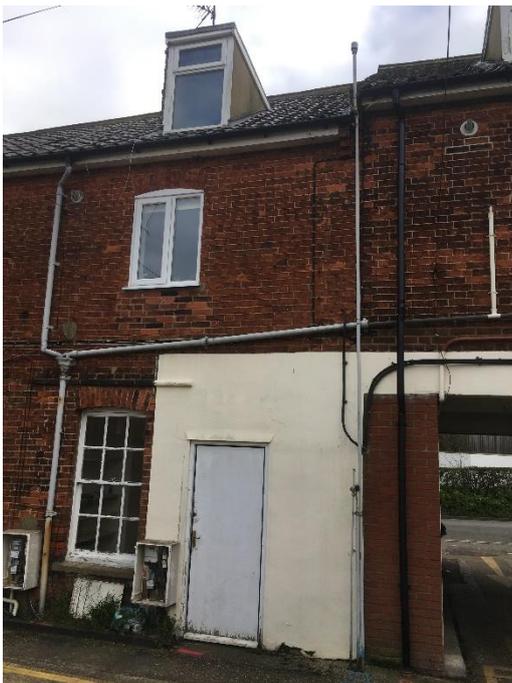
Photograph No. 8 – Rear elevation of Unit 5

- 5.3.6 The rear west facing elevation comprises of face brickwork with brick arches to the window openings. There is a small section of rendered masonry around the rear door, adjacent to the access passageway.

- 5.3.7 There is no evidence of any significant structural issues to any of the exposed elevations to this unit.
- 5.4 **No. 7 – Noir Hairdressing and No. 9 A – The Fisherman and Friends**

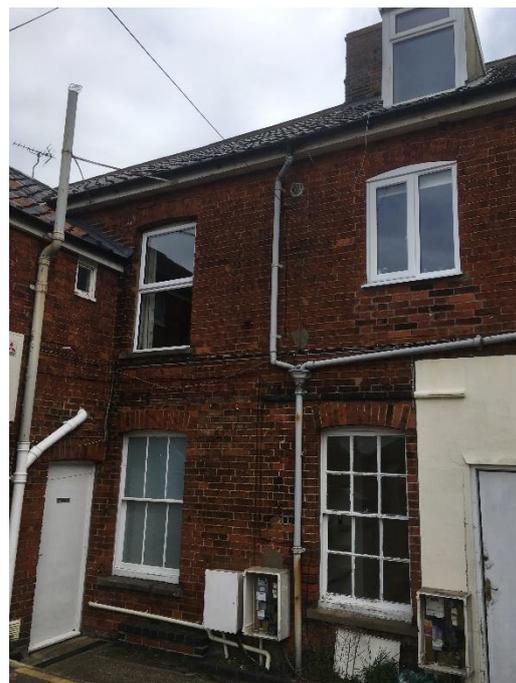
Photograph No. 9 - Rear elevation of Unit 3A & 5

- 5.2.7 The south and west facing elevations to the rear of Unit 3A are of face brickwork and incorporate brick arches to the window and door openings. There has been some minor cracking and repointing works have been undertaken above the toilet door to this section.

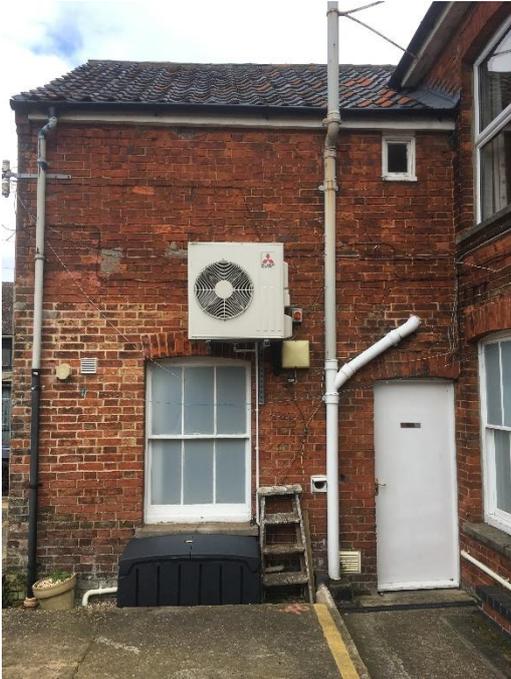
Photograph No. 10 – Rear elevation of Unit 3a

- 5.2.8 There has been some deterioration to the low level masonry on the west elevation which is considered to be attributable to water action due defective rain water goods. This has caused erosion of the bed joints to a localised section of brickwork.

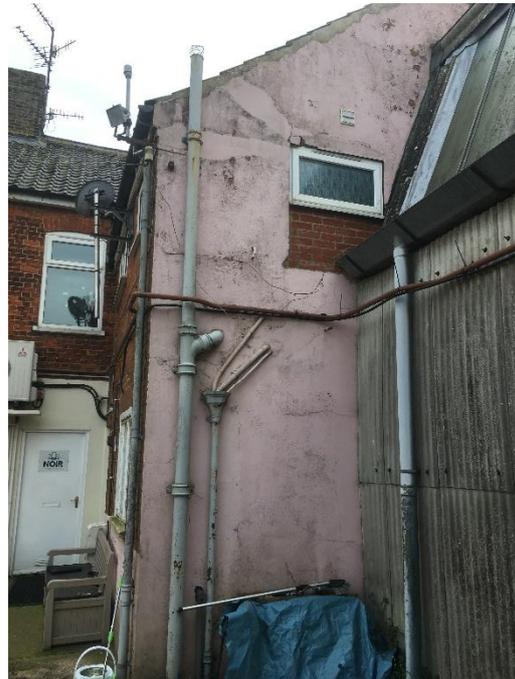
Photograph No. 11 – Rear corner of Unit 7

- 5.4.5 The south and north facing elevations to the rear of Unit 7 are of face brickwork and incorporate brick arches to the window and door openings. The brickwork is painted below cill level to the North elevation.

- 5.4.6 The gable end is rendered and painted pink where visible. The render is in poor condition with cracking evident above and to the sides of the first floor window.
