27 March 2020
IE20/016/CSJ/rmc

INSPECTION OF BELOW GROUND TANKS - JUNCTION OF STATION ROAD AND BLYTH ROAD, SOUTHWOLD, IP18 6AX

Analytical Report Number : 20-93431

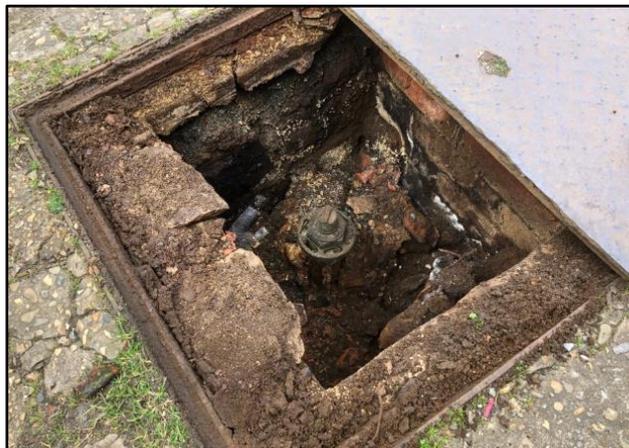
Tank 1

2.02.4 Tanks 1, 5, 6 & 7 were inspected and confirmed as decommissioned with hard foam. The foam was visible within the refuelling apparatus. This a relatively modern method of decommissioning underground storage tanks, which prevents an accumulation of explosive vapour arising from residual contents. Photographs of the tank refuelling chambers are shown below and overleaf.

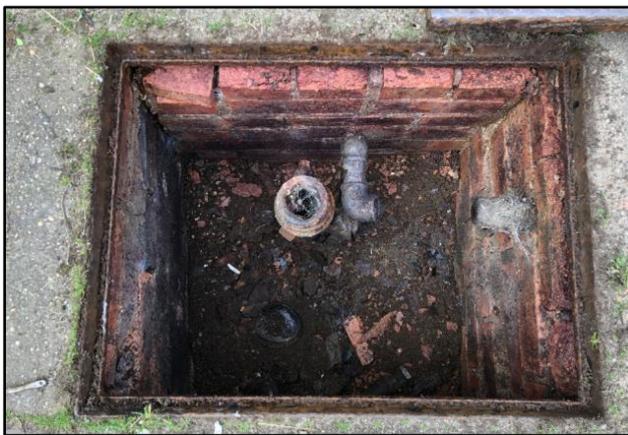
Tank 4

2.02.5 Tanks 4, 9A, 9B, and 10 were inspected and confirmed as containing oily water. Photographs of the tanks are shown below and overleaf.

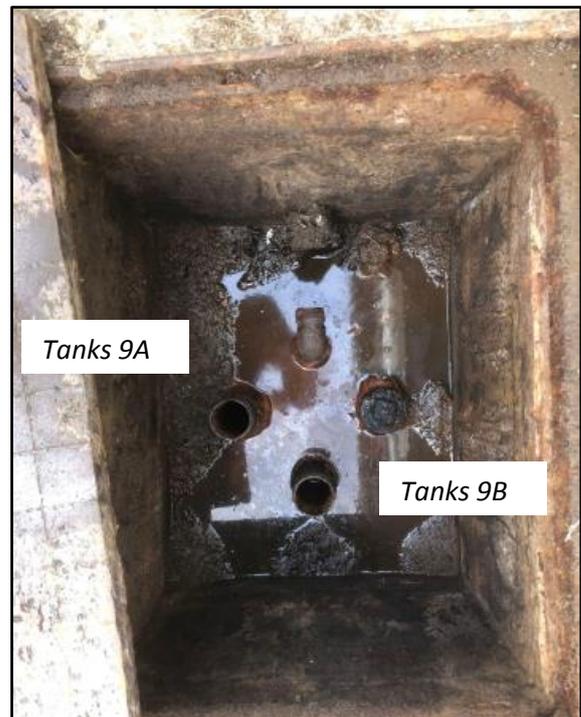
Tanks 9A & 9B

2.02.12 At Tanks 9A, 9B and Tank 10, the contents had the appearance of oily water. The laboratory test results show significant concentrations of both aliphatic and aromatic petroleum hydrocarbons, and BTEX compounds (benzene, toluene, ethylbenzene and xylene).

3.01.1 As the contents of Tanks 2, 9A, 9B and Tank 10 are all liquid, the contents will need to be pumped out by a tanker and the tanks de-gassed. This should take place in conjunction with the tank removal contract so that there is no risk of any gas accumulation.

3.01.2 The tank contents must be taken to at a suitably permitted waste transfer or treatment facility, ensuring that a hazardous waste consignment note is provided for each tanker of waste removed from site.

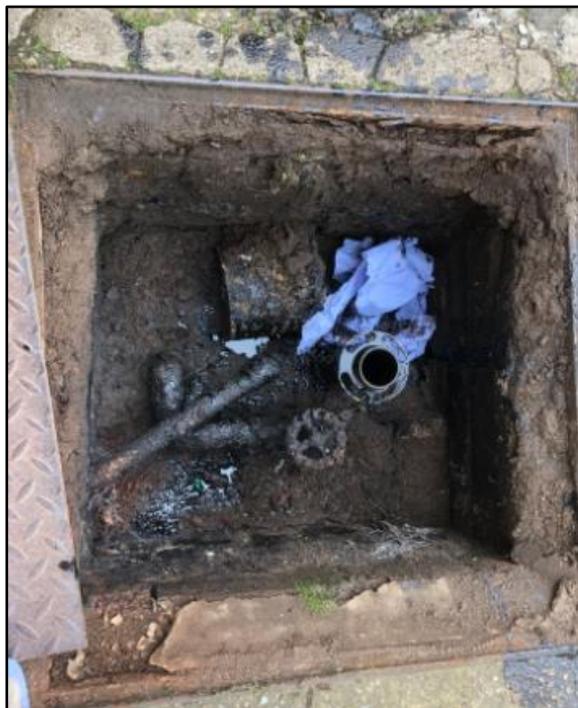
Tank 2

2.02.6 Tank 2, was inspected and found to contain what appeared to be waste engine oil. See image below.

2.02.11 At Tank 2, the sample was a dark brown to black oil. The laboratory test report states that although the sample does not match their product database it is indicative of a 'Lube Oil'. Based on the colour it is our considered opinion that contents are likely to be waste engine oil.

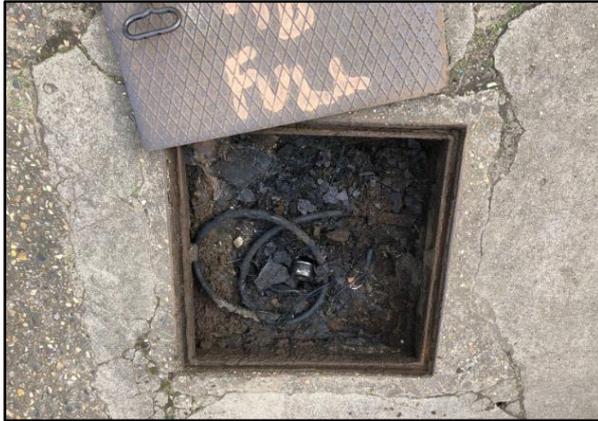
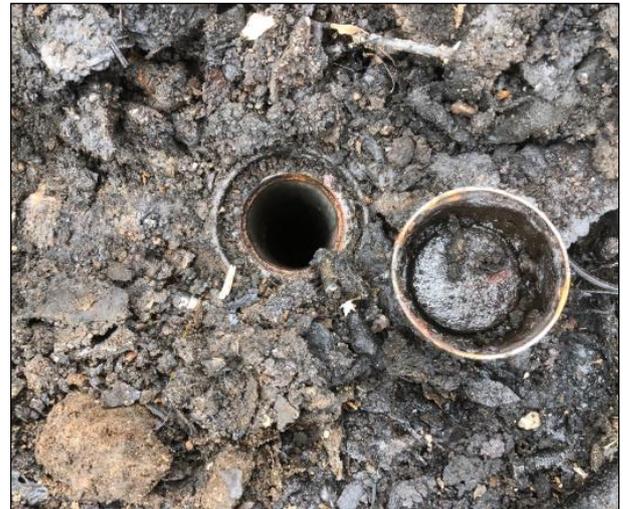
Tank 3

2.02.7 The refuelling chamber to Tank 3, was found to contain oily debris, however we were able to locate and remove the refuelling standpipe. See images below.

2.02.8 The refuelling chamber to Tank 3, was found to contain oily debris, however we were able to locate and remove the cover of the refuelling standpipe. Unfortunately, the pipe was blocked at a depth of approximately 1.0m the top of pipe. No liquid contents were encountered.

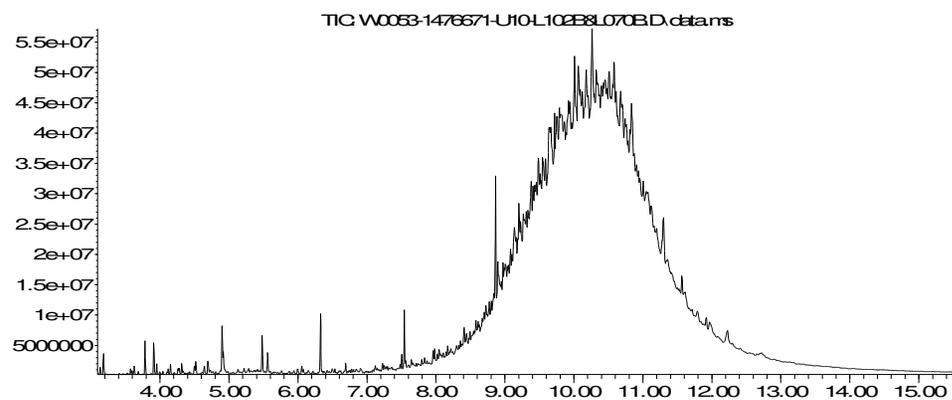
The total ion count (TIC trace) shows a carbon range from C10 to C40.
The sample TIC trace is complex, showing mainly aliphatic and some of aromatic product sources.
The trace does not match the standard product profiles but is suggestive of lube oil.
