**Site at Junction of Station Road & Blyth Road,  
Southwold  
IP18 6AX**

**Structural Appraisal of Units 1-13**

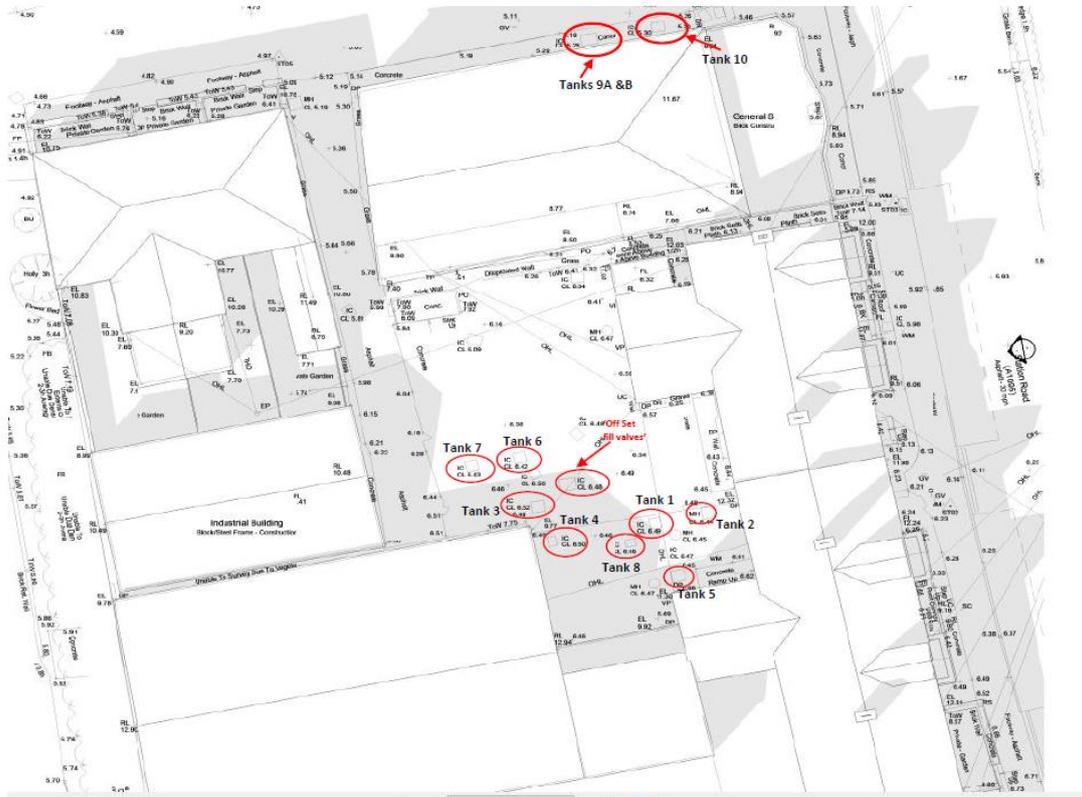
**Existing Site Plan**

- 7.1 A total of 11 below ground tanks were identified by JPC Environmental services, with a further potential tank located to the rear of Unit 3, which could not be investigated during the inspection.
- 7.2 The tank locations and associated sizes are noted with report reference IE20/016/CSJ but for completeness are as follows:

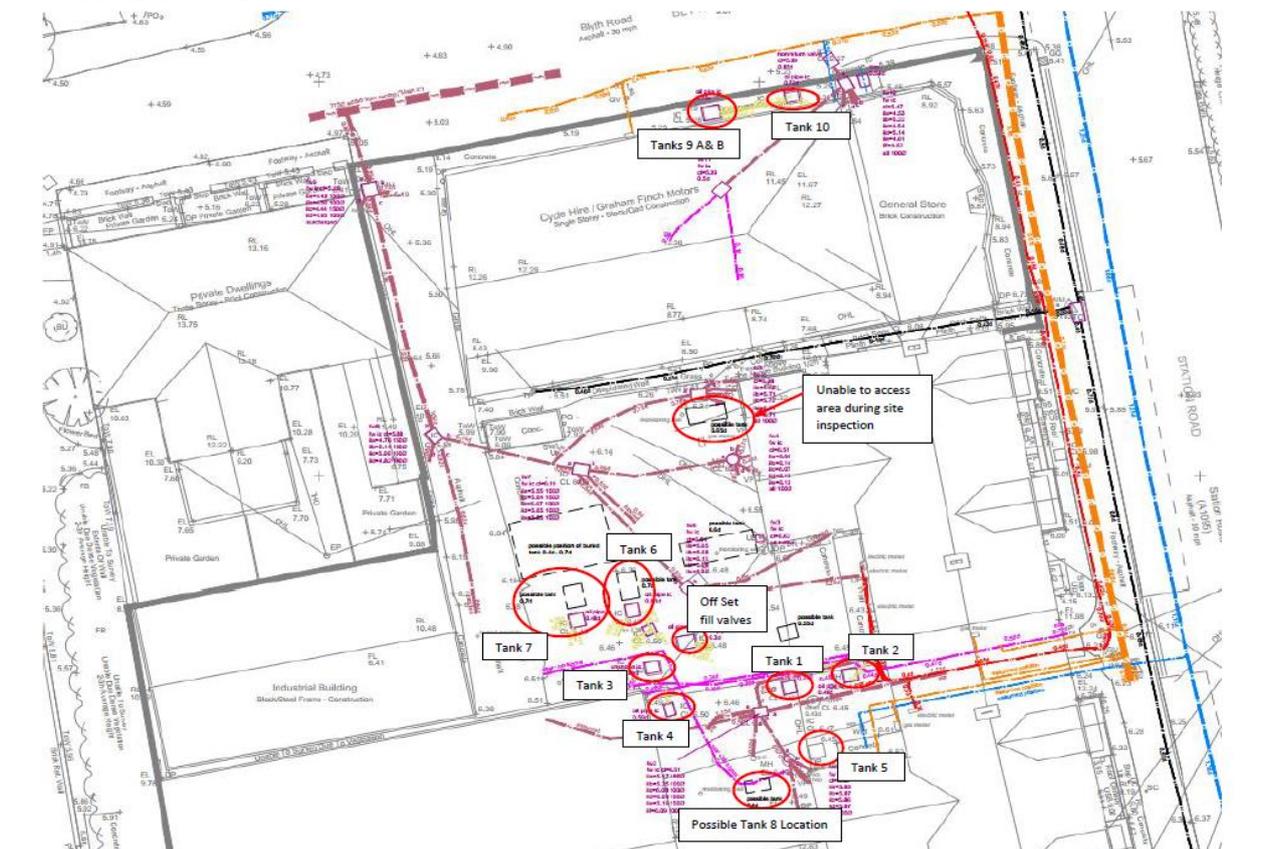
**GPR, CCTV, Utility Survey**

- 7.5 Tank 1 is located approximately 4 m remote from Unit 5 and therefore it is considered that this may be simply excavated without any special precautions, subject to the existing foundation provision being of suitable depth.

- 7.6 Tank 2 however is only approximately 1.0 m remote from the rear of Unit 5. It is therefore recommended that the tank be carefully exposed and precisely located. The existing foundation will need to be exposed to confirm its depth and construction. Following this an appropriate temporary works design and method statement will need to be established to safely remove the tank and provide a suitable backfill material. This will likely be temporary shoring with sheet piling.

- 7.8 Tank 5 appears to be within 1.0 m of the foundation to the rear of Unit 7. This will need to be addressed as per the recommendations for Tank 2 above.

- 7.9 Tanks 6 and 7 are larger than the general tanks and noted as being 1.6 m in diameter. However these are located toward the centre of the courtyard and sufficiently remote from any structures such that their removal will not adversely affect any existing foundations.

- 7.10 Tank 8 appears to be within 2.0 m of the foundation to the rear of Unit 7, however it was not possible to ascertain the tanks size and depth. This will need to be confirmed and if the excavation will result in undermining of the adjacent foundations the recommendations will be as for Tank 2 above.

- 8.1 In summary the foundations to the rear projections of Units 3, 5 and 7 will require exposing and assessment by J P Chick and Partners Ltd. Once foundations and supporting strata have been established, this can be reviewed against the required excavation depths for tanks 2, 5 and 8. The potential tank to the rear of Unit 3 will also need to be investigated for its depth and location etc.

- 8.2 Temporary shoring will be required where the excavations undermine existing foundations. This will need to be designed by a suitably qualified and experienced temporary works designer.
